RE: Site Inspection, Karl Truman and Ted Carter, Truman/Carter Mine, S/021/022, Iron County, Utah

Date of Inspection: February 27, 2002

Photographs of Disturbed Areas, Karl Truman and Ted Carter, Truman/Carter Mine, M/021/022,  
Iron County, Utah, February 27, 2002

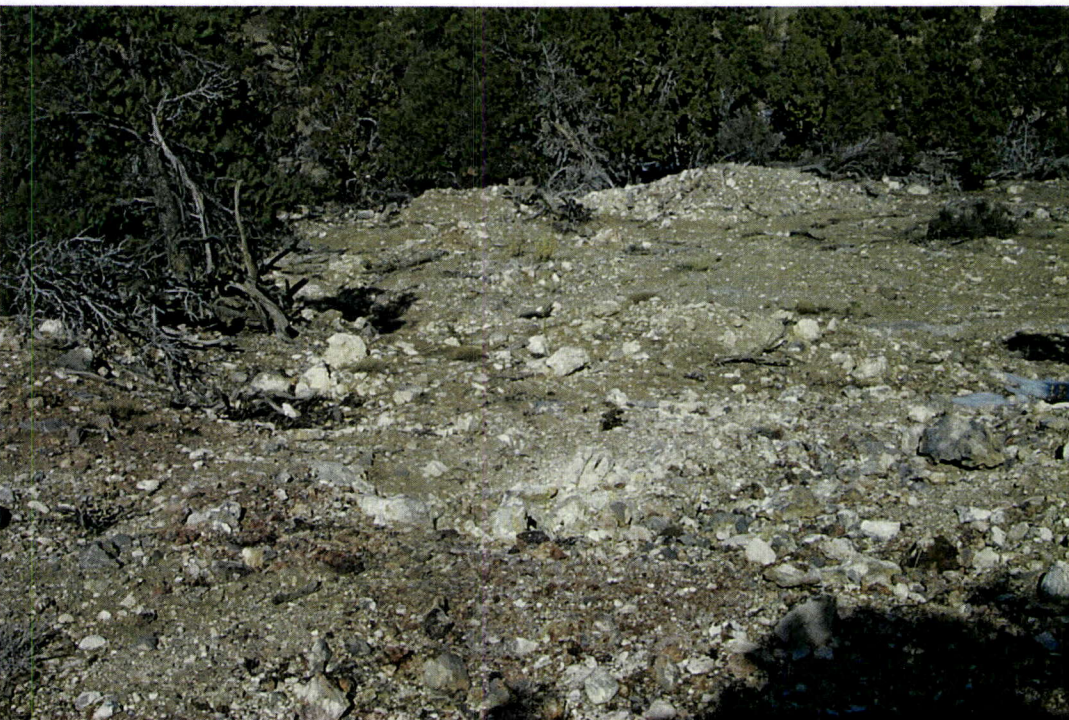
Photo 6

The disturbed areas are more like exploration trenches than mining areas. The last work was done in about 1995. It did not appear any topsoil was salvaged at any of these areas, and the only site where it appeared some regrading might have been done was the uppermost site near the saddle (Photo 6).

Most of the disturbances are a few hundred square feet, but the uppermost site is about 2000 square feet. I did not attempt to pace the disturbance areas, but I estimate the total disturbance is probably about 2-3 acres including the roads.
